Vulcan Treatment in Grease Trap

Test report on the pulsed water treatment system provided with preventive measures against clogging in the drainpipe under the sink in the cookery on the fifth floor.

December 22, 2007

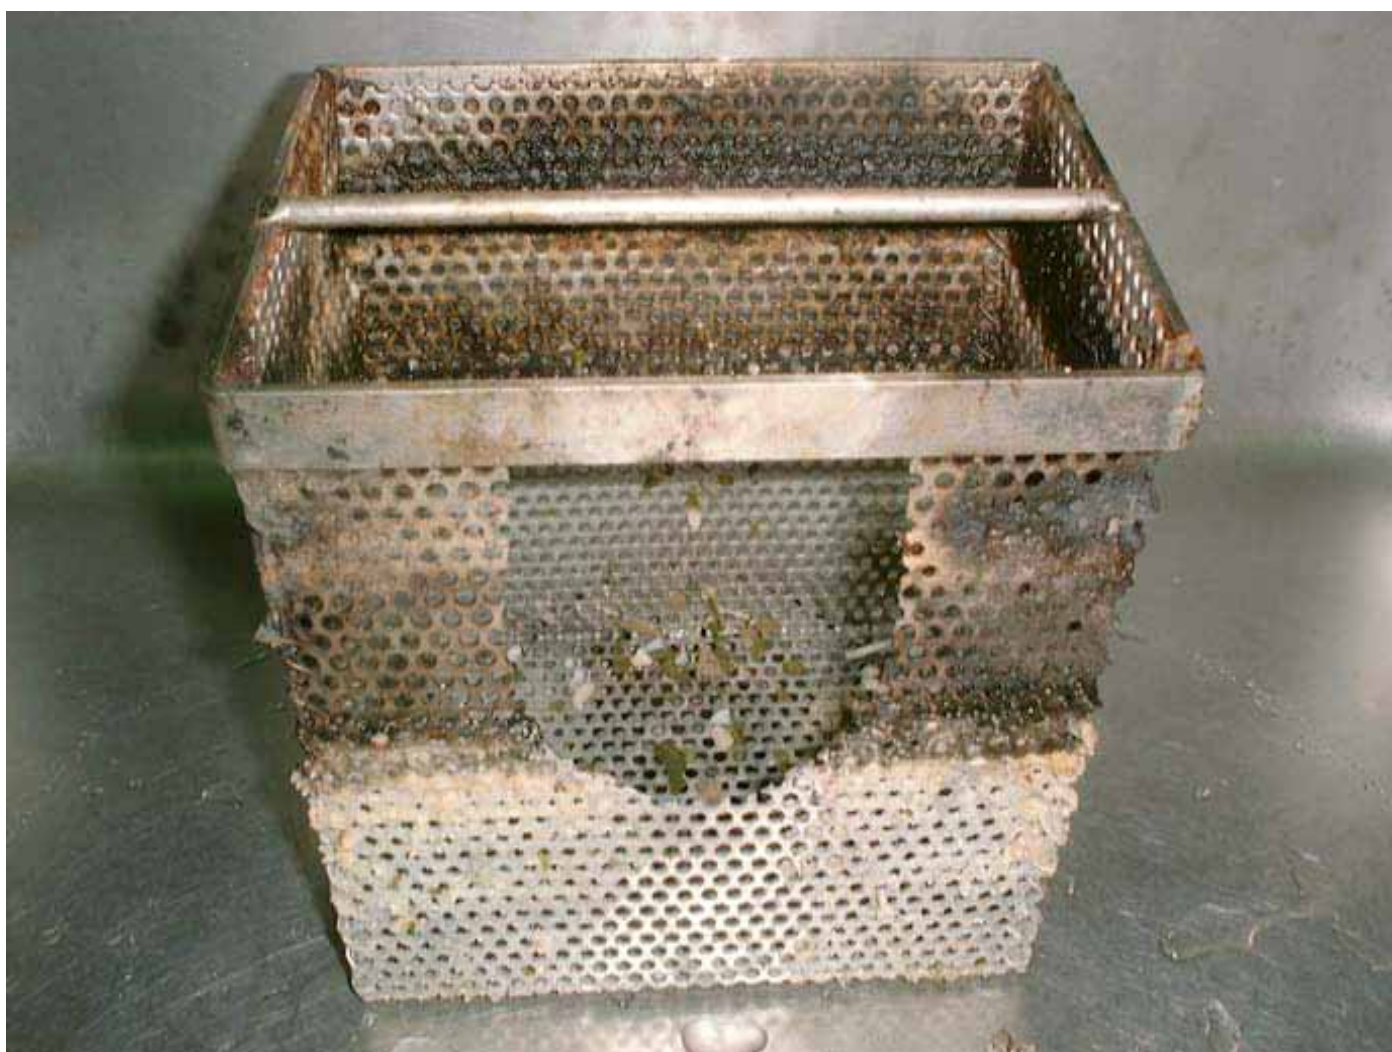
The status after the cleaning on September 20 was inspected on November 11, 2006. Almost no adhesion of dirt is seen, thus the effect of this treatment water is recognized.

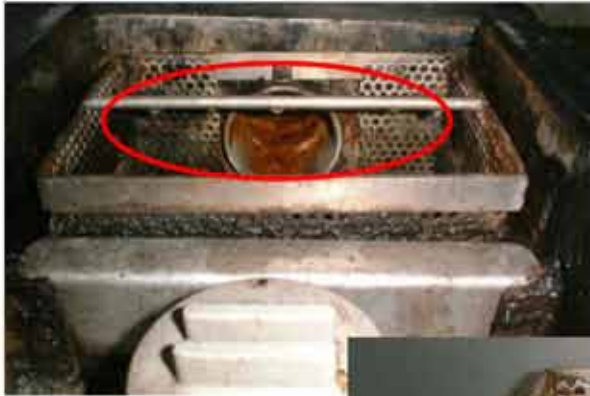
On September 12 (three months after the installation of the Vulcan)

The status of the grease trap three months after the installation:
Compared with the time of installation, the peripheries of the basket drain have gotten dry.

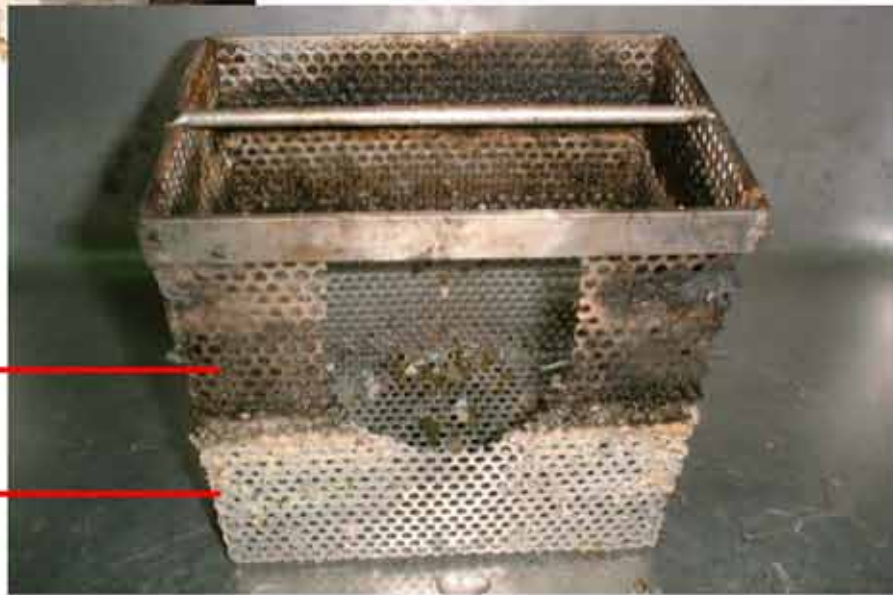
Usual water level upon installation

Standing water level has been lowered due to better drainage achieved by removal of the objects adhered on the basket.

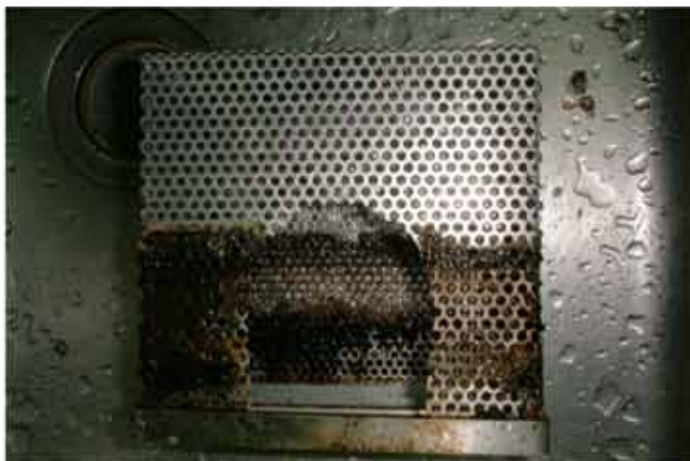
The photo below shows the status of the basket after being washed by hosing. The portions usually being contacted with the treatment water are cleaned easily with a water flow from the tap. Native dark color of stainless steel can be recognized after cleaning.

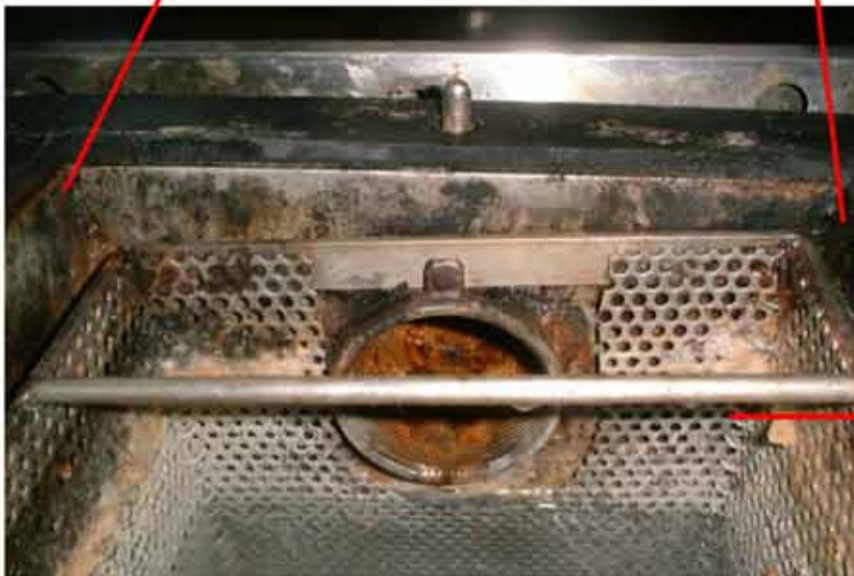
Grease trap under the countertop

Usual level of the standing water: Water flows up to the level indicated by **a**.

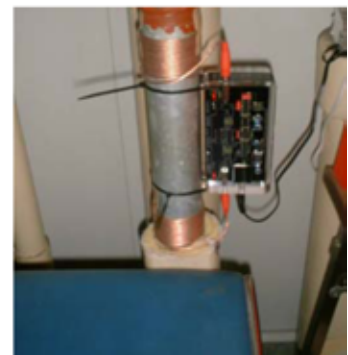
Piping size: 50A. (The photo on the right shows the Vulcan installed)

Model installed: Vulcan 5000 (water treatment capacity: 5 m³/hour)
